Chesapeake Boulevard (between East Little Creek Rd & Fishermans Rd) Pedestrian & Drainage Preliminary Engineering Report

City of Norfolk, Virginia

Department of Public Works

Timmons Group

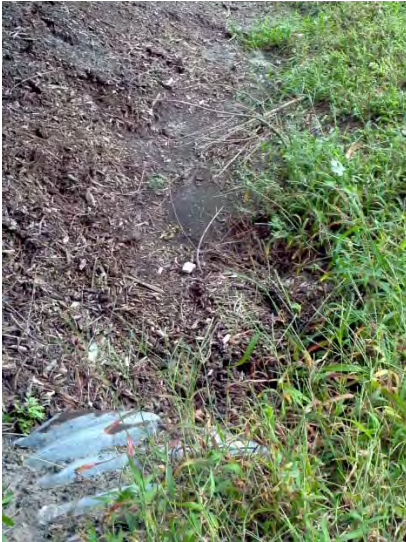
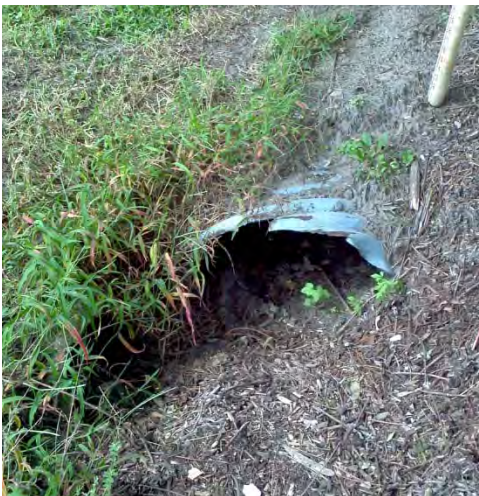
Structure Number **I06130.01**

Notes: pipe at 9 o'clock a stub?

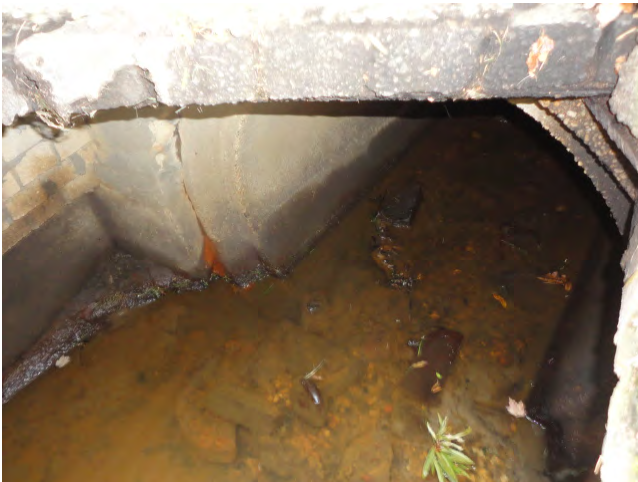
Pic 2 (inside structure w/ pipe out @ 12 o'clock)

Notes: 0.5' of water in structure

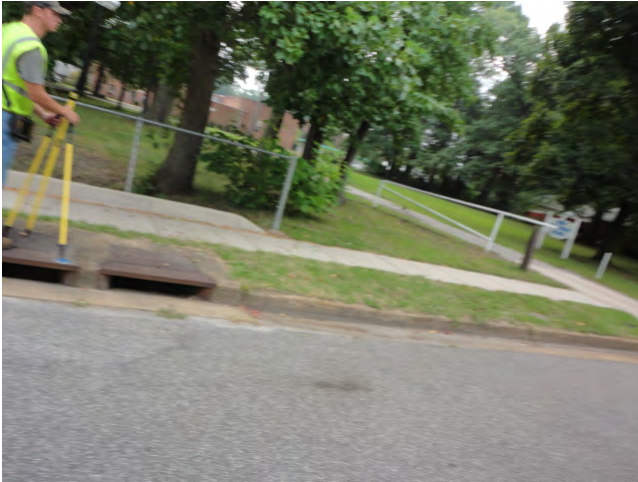
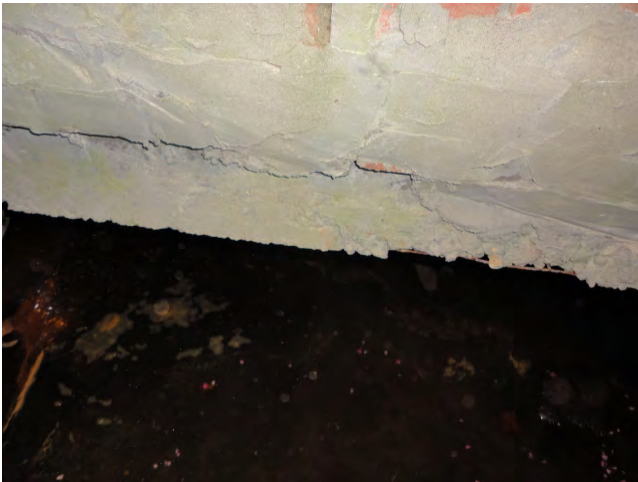
Structure Number **J0679**

Notes: water in structure

Condition G (**Poor** , **Fair** , **Good** , **Awaiting Install** , **Removed from Service**)

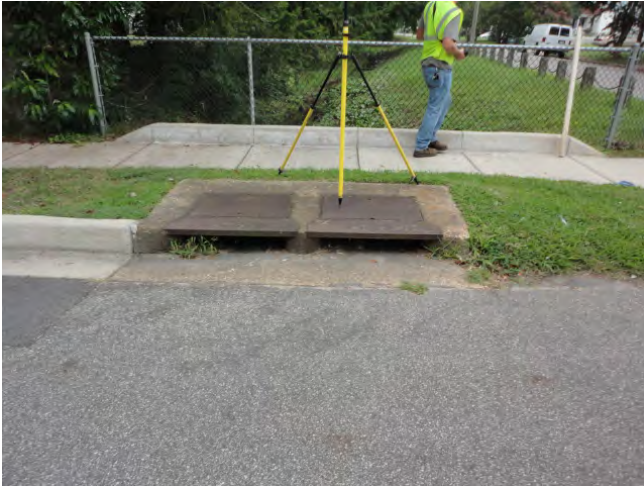
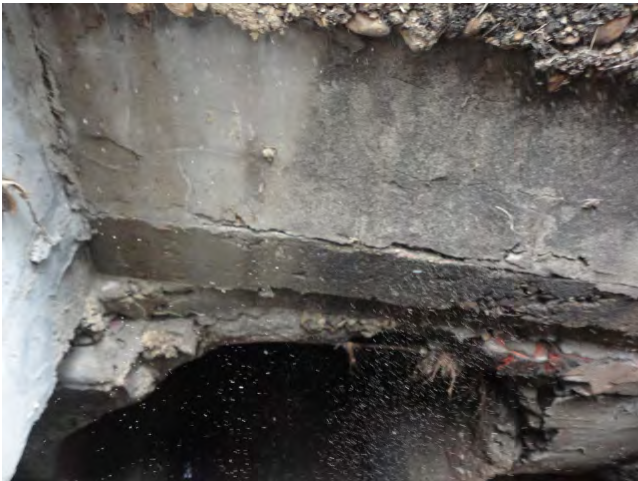
Structure Number **J0684**

Notes: 0.5' feet of water in structure

Condition G(**P**oor , **F**air , **G**ood , **A**waiting Install , **R**emoved from Service)

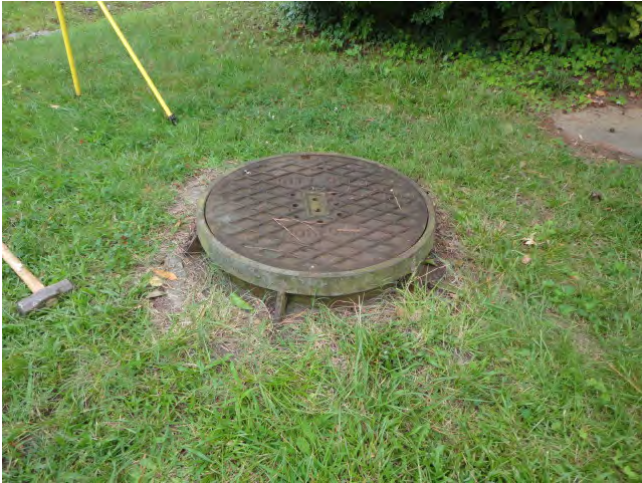
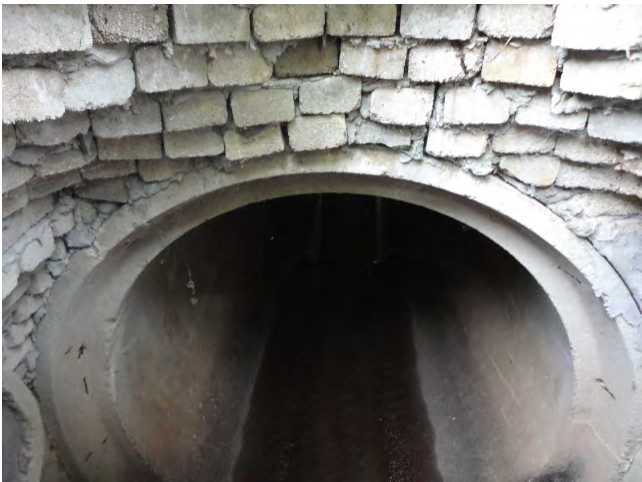
Structure Number **J0690**

Notes: large rocks at bottom of structure

Condition G(**P**oor , **F**air , **G**ood , **A**waiting Install , **R**emoved from Service)

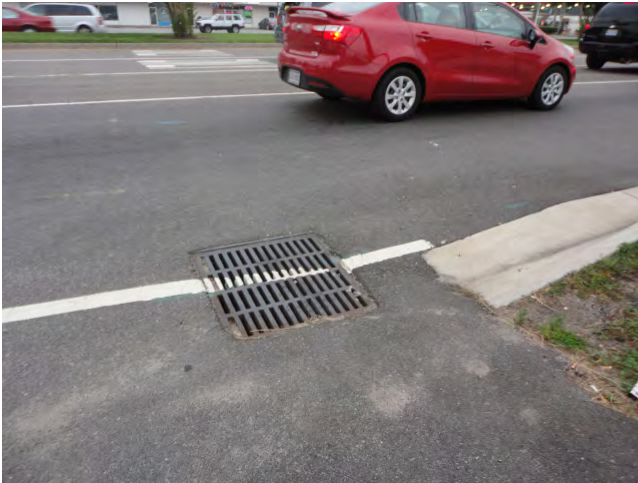
Structure Number **J071099**

Condition F (**P**oor , **F**air , **G**ood , **A**waiting Install , **R**emoved from Service)

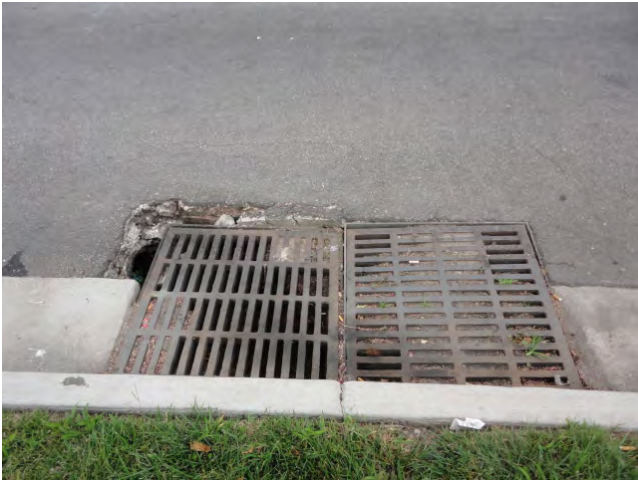
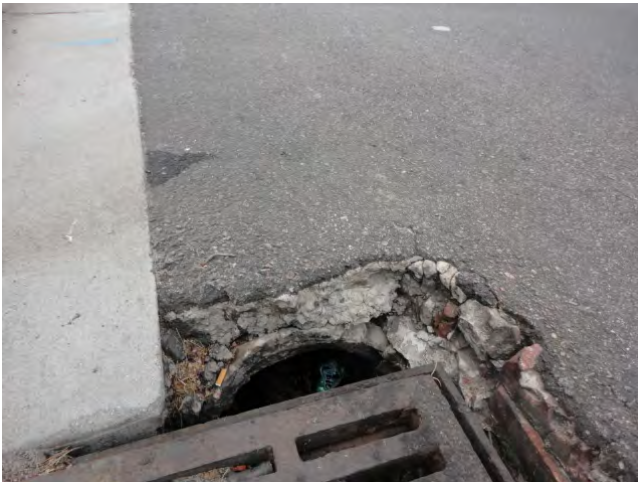
Structure Number **J071103**

Condition P (**P**oor , **F**air , **G**ood , **A**waiting Install , **R**emoved from Service)

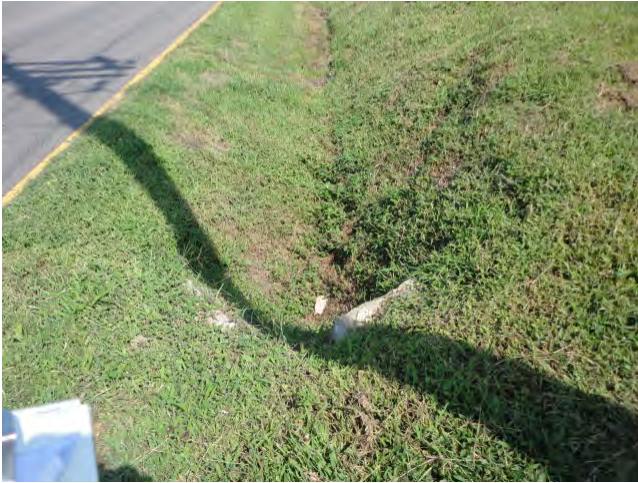
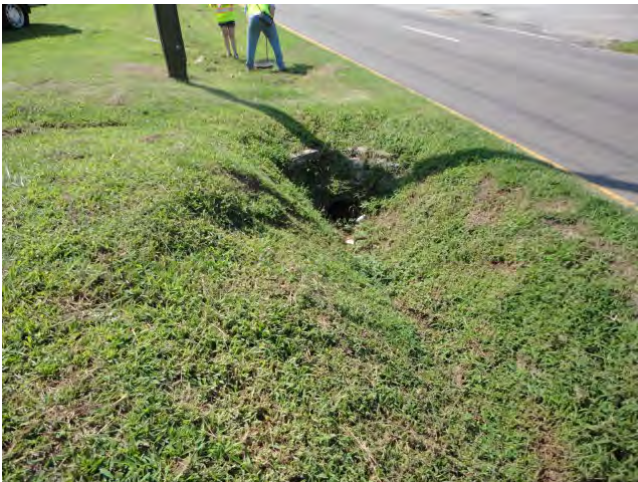
Structure Number **I05148**

Notes: ditch depth decreases to 2.3'

Pipe Condition G (**P**oor , **F**air , **G**ood , **A**waiting Install , **R**emoved from Service)

Ditch Condition	Bottom Width, ft	Top Width, ft	Depth, ft	Side Slopes (ft/ft)
G	0.5	6	3.60	0.764

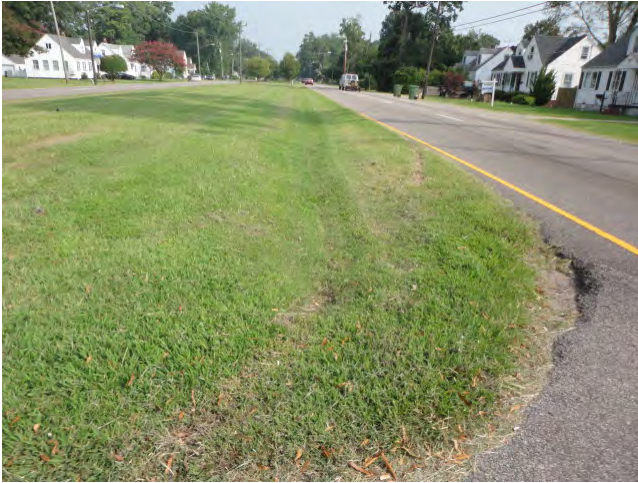
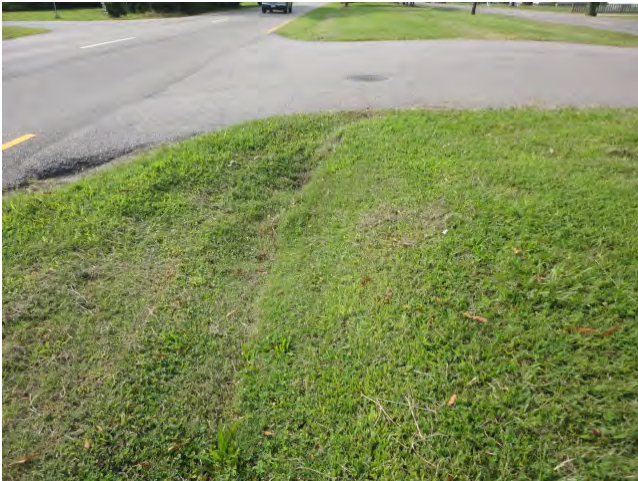
Structure Number **I061003**

Ditch Condition	Bottom Width, ft	Top Width, ft	Depth, ft	Side Slopes (ft/ft)
P

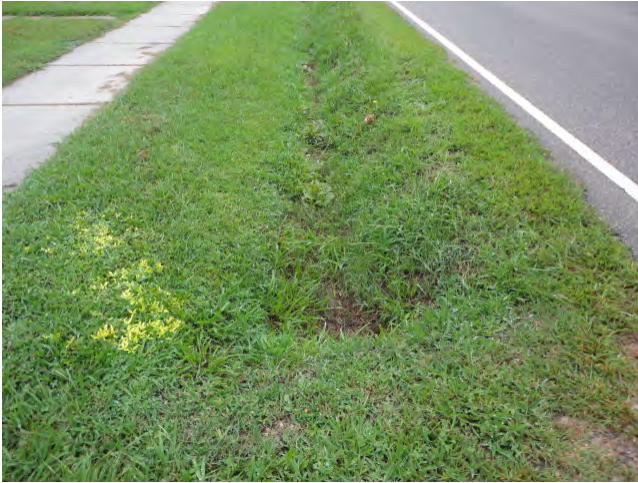
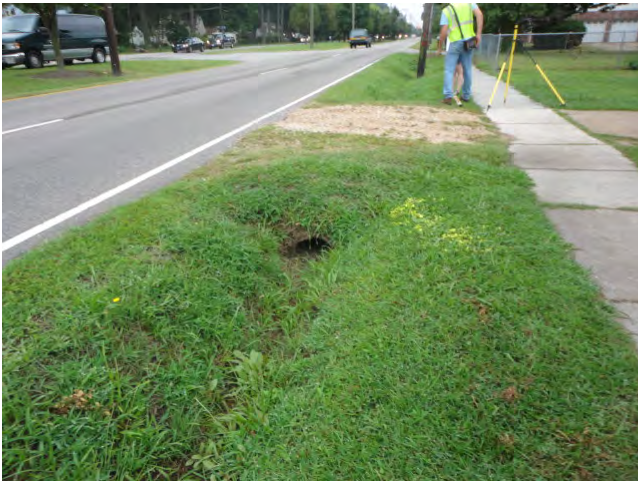
Structure Number **I061151**

Notes: 0.1' of sediment in ditch; pipe squashed

Pipe Condition E(**P**oor , **F**air , **G**ood , **A**waiting Install , **R**emoved from Service)

Ditch Condition	Bottom Width, ft	Top Width, ft	Depth, ft	Side Slopes (ft/ft)
G	1	4	1.5	1

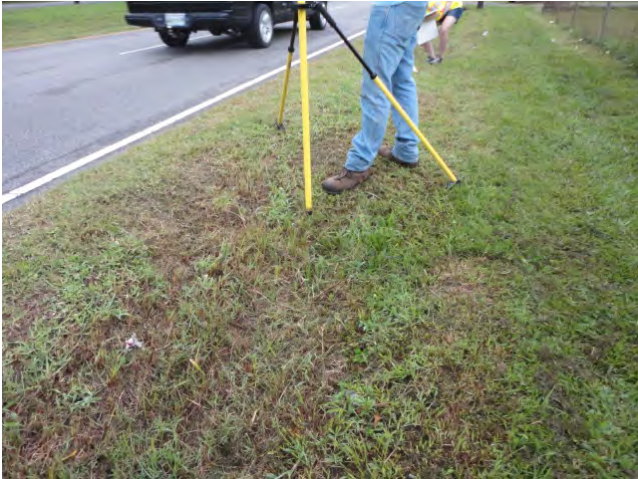
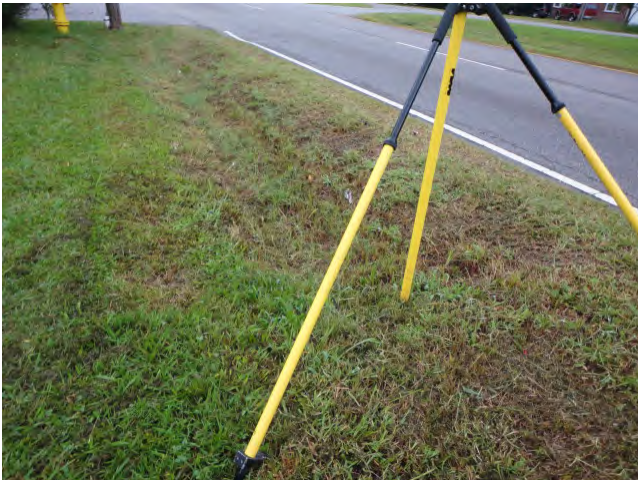
Structure Number **I06139**

Pipe Condition P (**P**oor , **F**air , **G**ood , **A**waiting Install , **R**emoved from Service)

Ditch Condition	Bottom Width, ft	Top Width, ft	Depth, ft	Side Slopes (ft/ft)
G	1	3	0.7	1.43

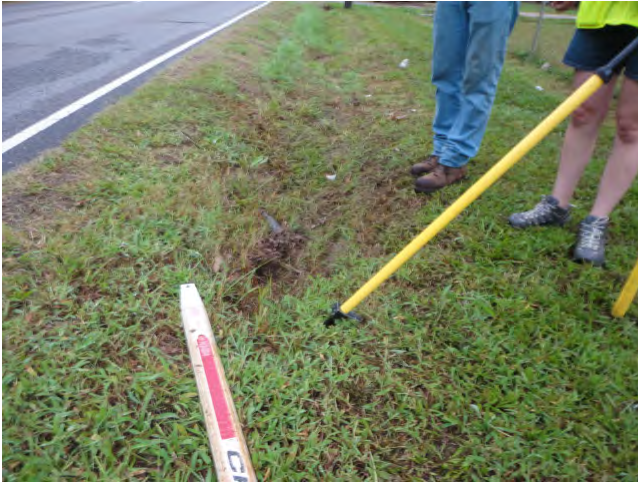
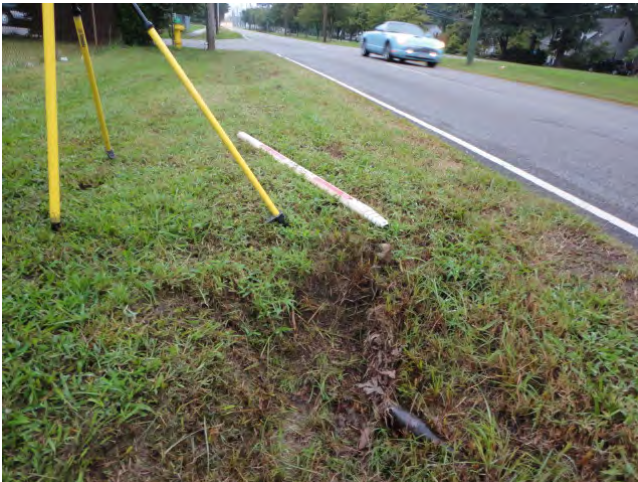
Structure Number **I06142**

Notes: could not really find pipe

Pipe Condition P (**P**oor , **F**air , **G**ood , **A**waiting Install , **R**emoved from Service)

Ditch Condition	Bottom Width, ft	Top Width, ft	Depth, ft	Side Slopes (ft/ft)
G	1.5	3.5	1	1

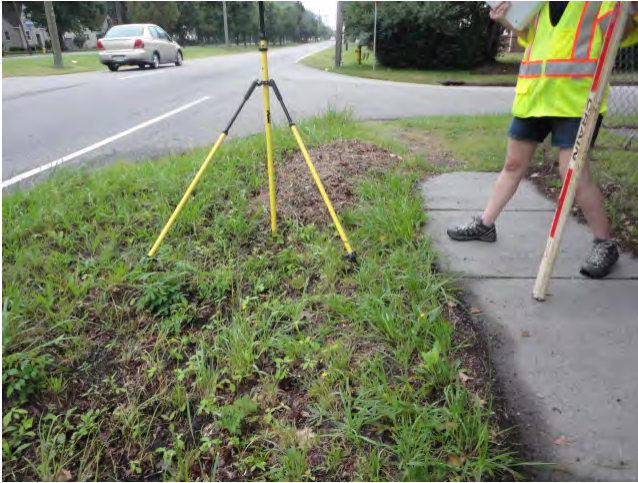
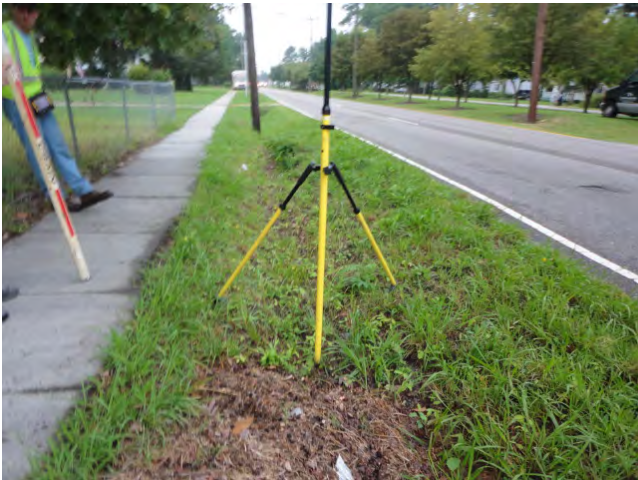
Structure Number **I06143**

Notes: ditch 10% filled with mulch

Pipe Condition NA (Poor , Fair , Good , Awaiting Install , Removed from Service)

Ditch Condition	Bottom Width, ft	Top Width, ft	Depth, ft	Side Slopes (ft/ft)
F	2	5	0.8	1.875

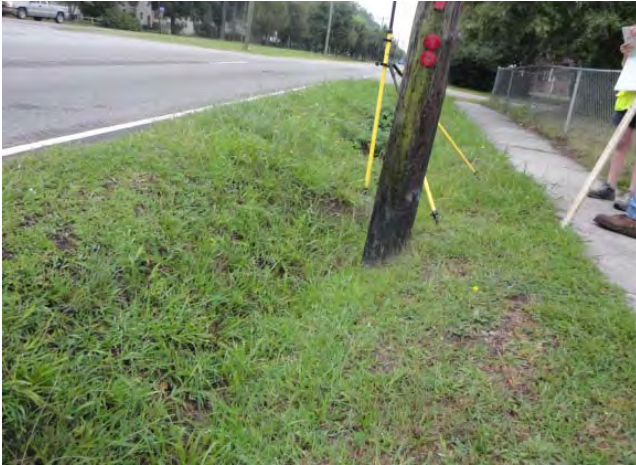
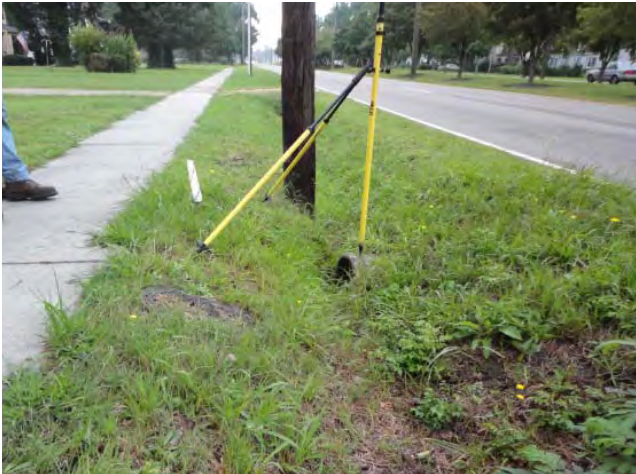
Structure Number **I06144**

Notes: ditch at 3 and 9 o'clock

Pipe Condition G (**P**oor , **F**air , **G**ood , **A**waiting Install , **R**emoved from Service)

Ditch Condition	Bottom Width, ft	Top Width, ft	Depth, ft	Side Slopes (ft/ft)
G	1	5	2.5	0.80

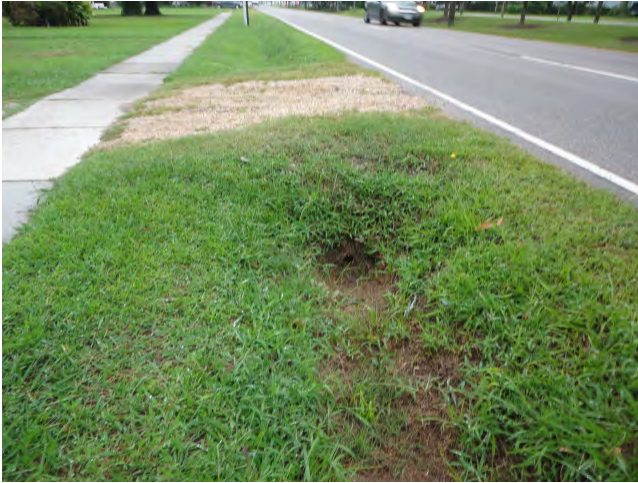
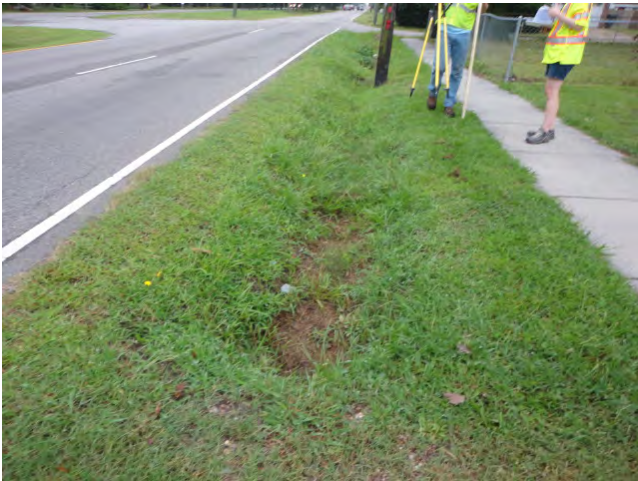
Structure Number **I06145**

Notes: pipe squashed

Pipe Condition P (**P**oor , **F**air , **G**ood , **A**waiting Install , **R**emoved from Service)

Ditch Condition	Bottom Width, ft	Top Width, ft	Depth, ft	Side Slopes (ft/ft)
G	1	3.5	2	0.625

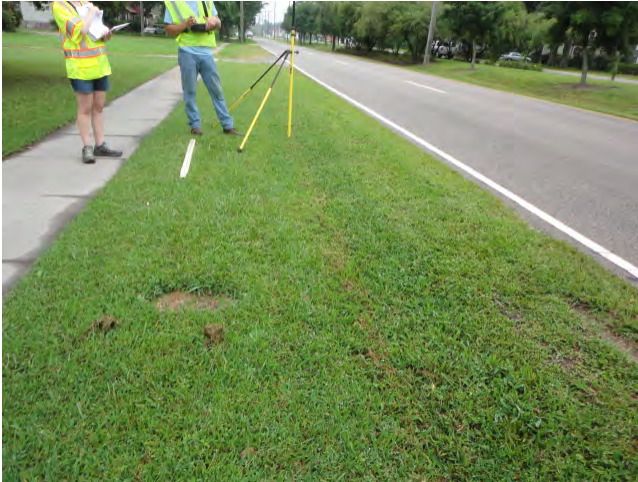
Structure Number **I06152**

Notes: portion is v-ditch; good condition

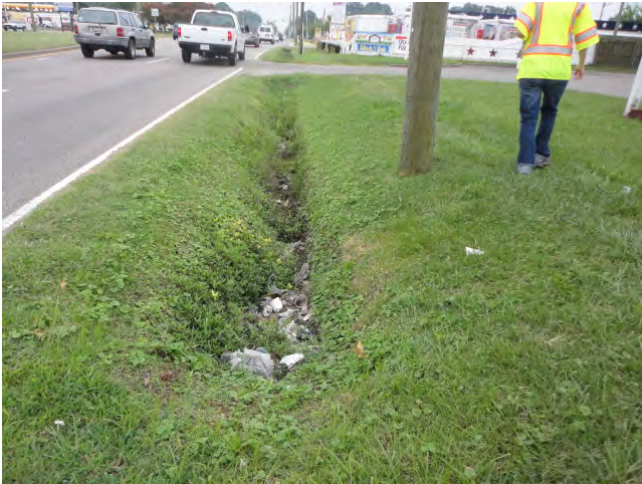
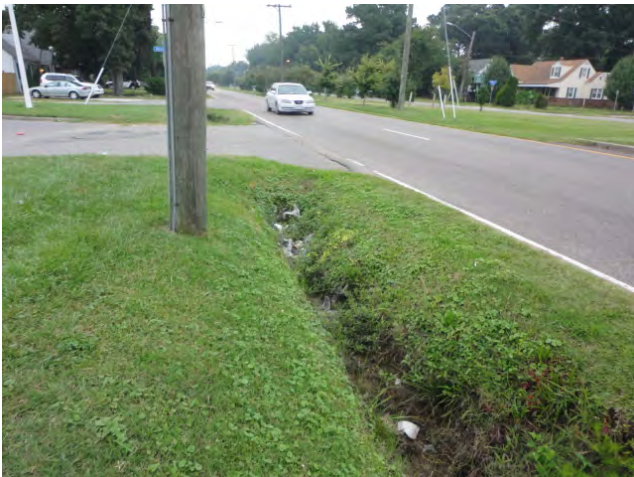
Structure Number **I071091**

Notes: pipe filled with trash

Pipe Condition P (**P**oor , **F**air , **G**ood , **A**waiting Install , **R**emoved from Service)

Ditch Condition	Bottom Width, ft	Top Width, ft	Depth, ft	Side Slopes (ft/ft)
G	1.5	4.5	2.5	0.6

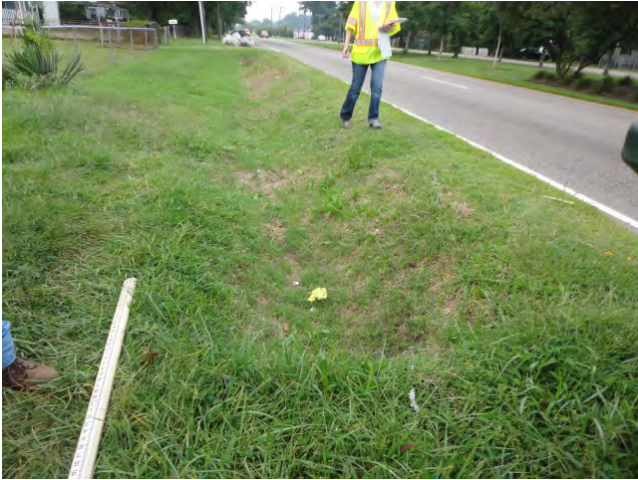
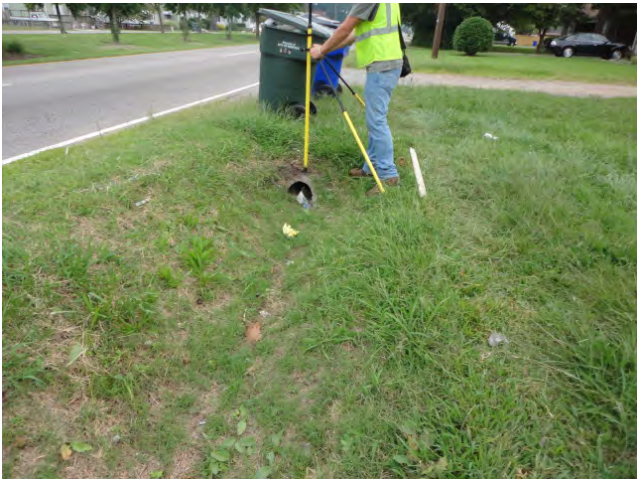
Structure Number **I073307**

Notes: covered with vegetation, dirt and trash

Pipe Condition E(**P**oor , **F**air , **G**ood , **A**waiting Install , **R**emoved from Service)

Ditch Condition	Bottom Width, ft	Top Width, ft	Depth, ft	Side Slopes (ft/ft)
G	1.5	3.5	1.2	0.83

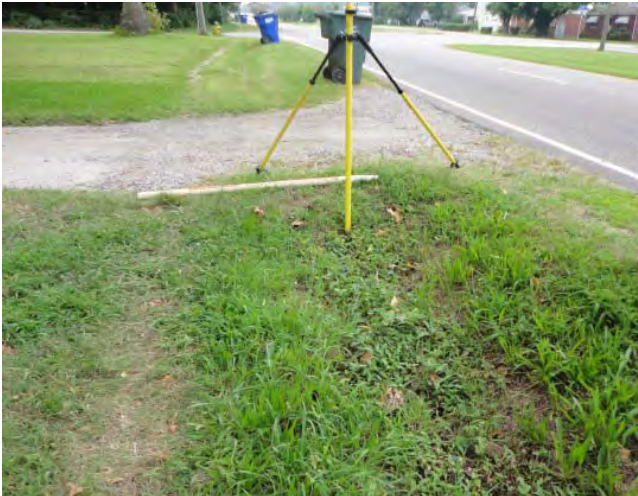
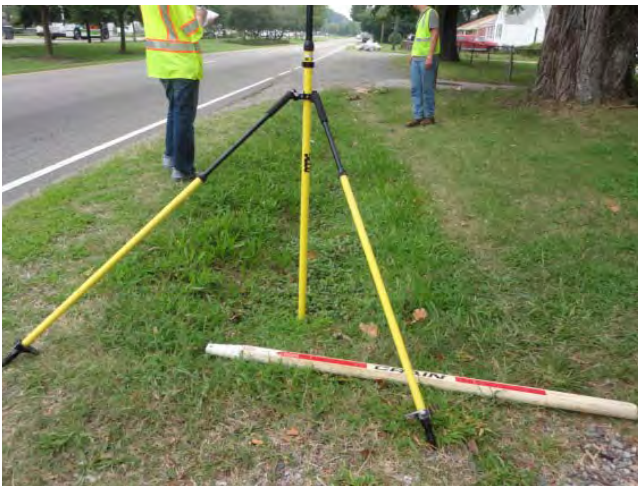
Structure Number **I073318**

Notes: pipe completely buried; ditch really a swale

Pipe Condition G (Poor , Fair , Good , Awaiting Install , Removed from Service)

Ditch Condition	Bottom Width, ft	Top Width, ft	Depth, ft	Side Slopes (ft/ft)
G	1	3	0.7	1.4

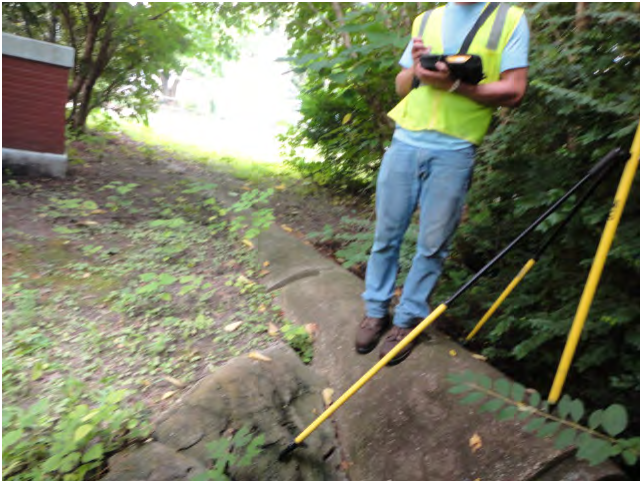
Pic 2 (Downstream)

Pipe Condition G (**P**oor , **F**air , **G**ood , **A**waiting Install , **R**emoved from Service)

Ditch Condition	Bottom Width, ft	Top Width, ft	Depth, ft	Side Slopes (ft/ft)
G	6	9	2	0.75

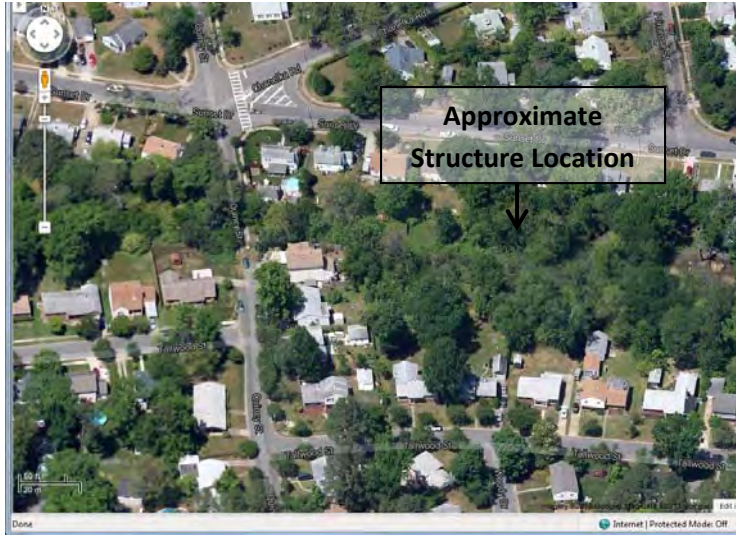
Structure Number **J0577**

Pipe Condition (**Poor** , Fair , Good , **Awaiting Install** , Removed from Service)

Ditch Condition	Bottom Width, ft	Top Width, ft	Depth, ft	Side Slopes (ft/ft)
UNK	UNK	UNK	UNK	UNK

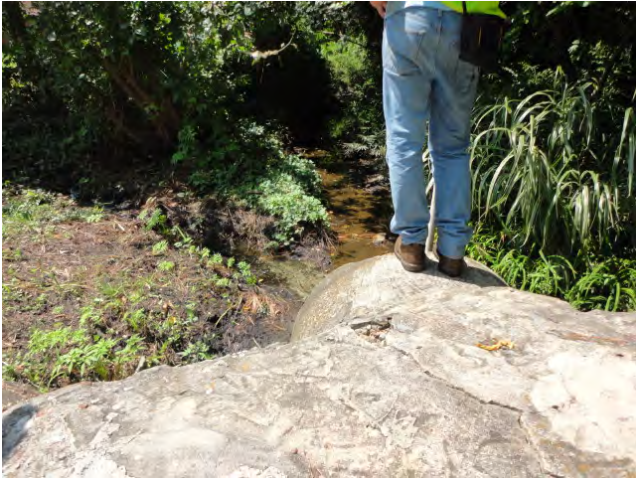
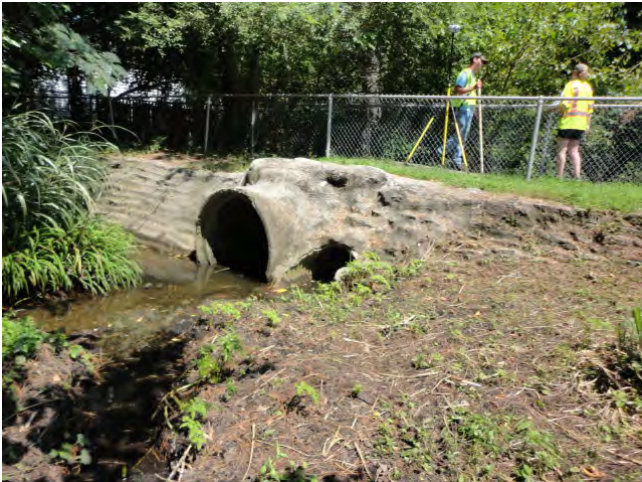
Structure Number **J0586**

Pipe Condition G (**P**oor , **F**air , **G**ood , **A**waiting Install , **R**emoved from Service)

Ditch Condition	Bottom Width, ft	Top Width, ft	Depth, ft	Side Slopes (ft/ft)
G	6	9	2	0.75

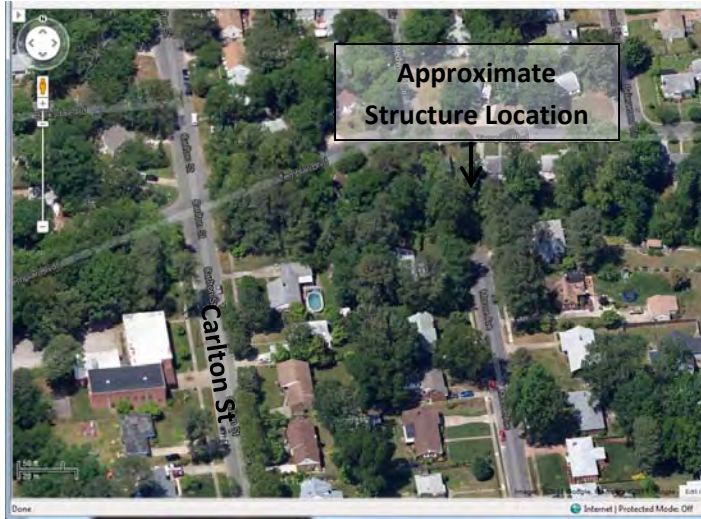
Structure Number **J0663**

Pipe Condition (**Poor** , Fair , Good , **Awaiting Install** , Removed from Service)

Ditch Condition	Bottom Width, ft	Top Width, ft	Depth, ft	Side Slopes (ft/ft)
UNK	UNK	UNK	UNK	UNK

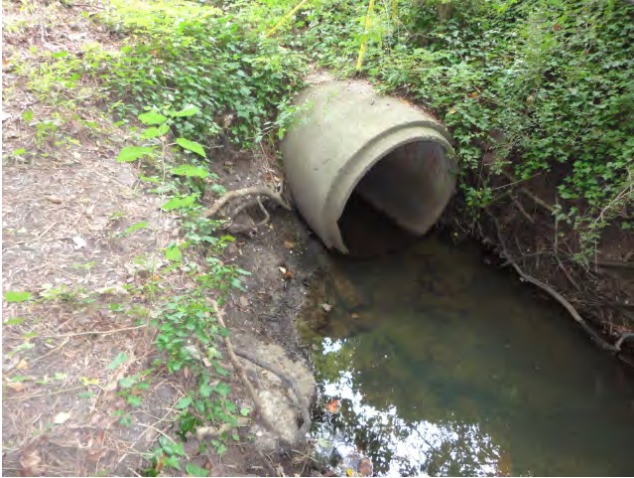
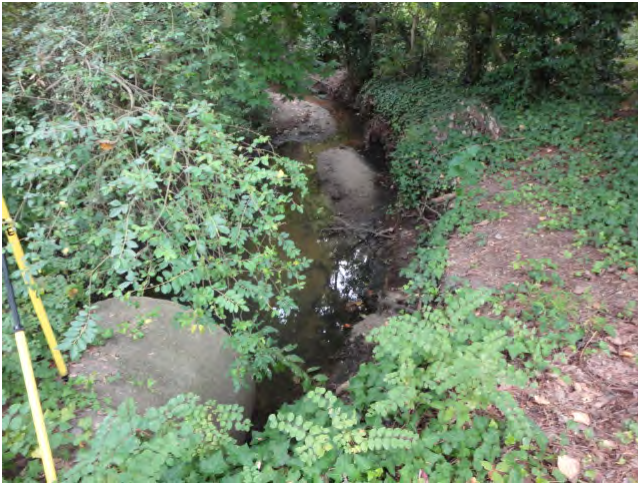
Structure Number **J0668**

Notes: water is 1-2' deep by pipe

Pipe Condition G (**P**oor , **F**air , **G**ood , **A**waiting Install , **R**emoved from Service)

Ditch Condition	Bottom Width, ft	Top Width, ft	Depth, ft	Side Slopes (ft/ft)
G	9	13	5	0.40

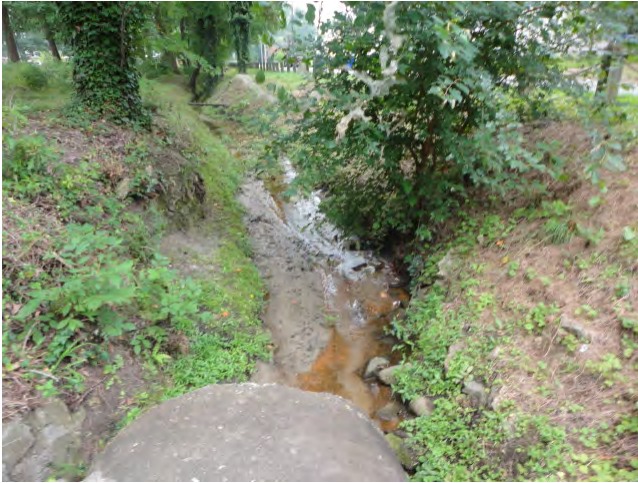
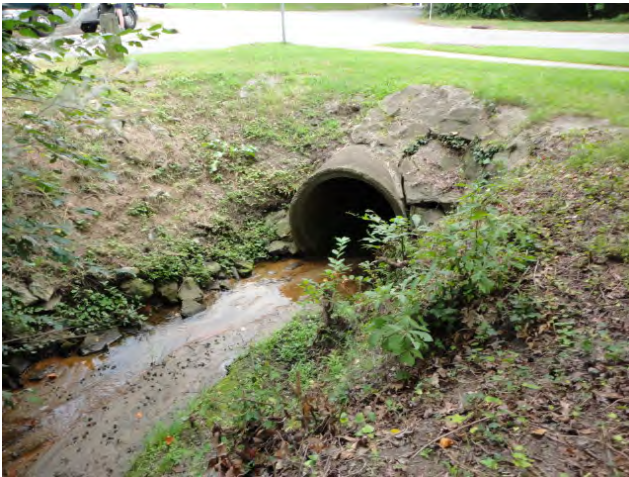
Structure Number **J0675**

Pipe Condition G (**P**oor , **F**air , **G**ood , **A**waiting Install , **R**emoved from Service)

Ditch Condition	Bottom Width, ft	Top Width, ft	Depth, ft	Side Slopes (ft/ft)
G	5	18	6	1.08

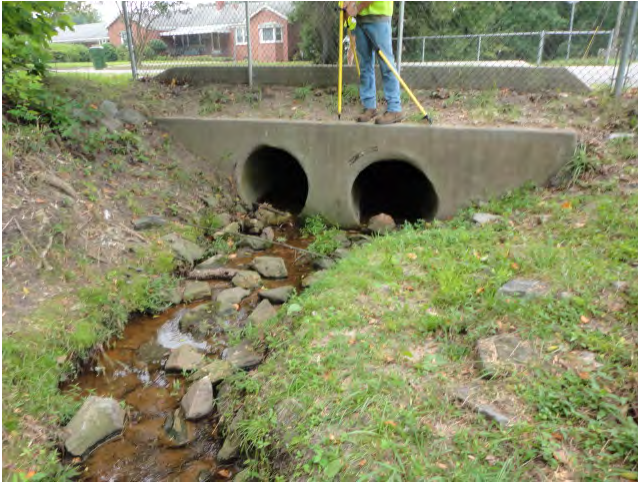
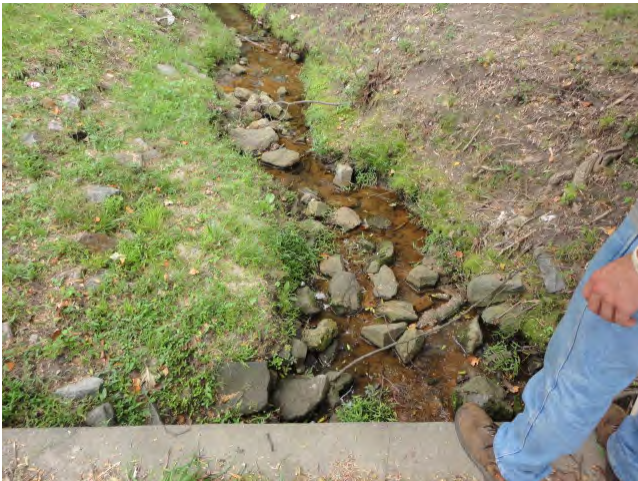
Structure Number **J0677**

Pipe Condition G (**P**oor , **F**air , **G**ood , **A**waiting Install , **R**emoved from Service)

Ditch Condition	Bottom Width, ft	Top Width, ft	Depth, ft	Side Slopes (ft/ft)
G	5	12	5.5	0.63

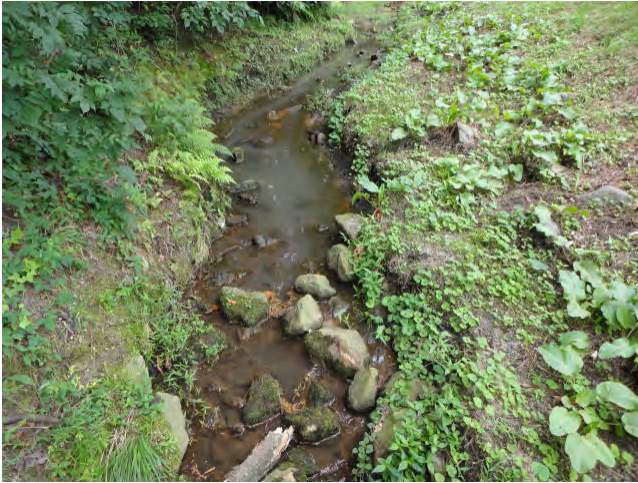
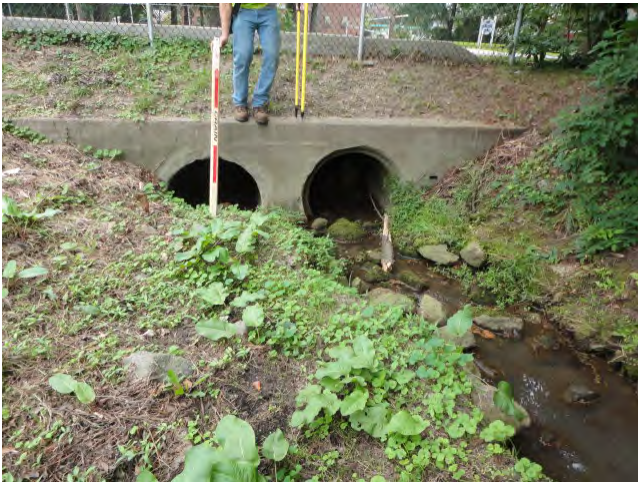
Structure Number **J0686**

Pipe Condition G (Poor , Fair , Good , Awaiting Install , Removed from Service)

Ditch Condition	Bottom Width, ft	Top Width, ft	Depth, ft	Side Slopes (ft/ft)
G	4	19	4	1.875

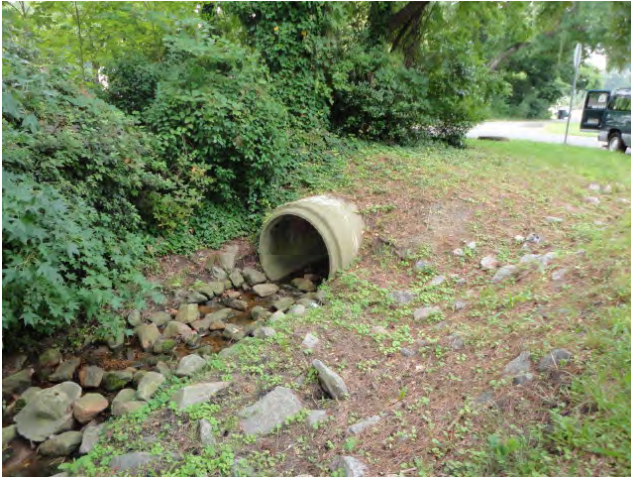
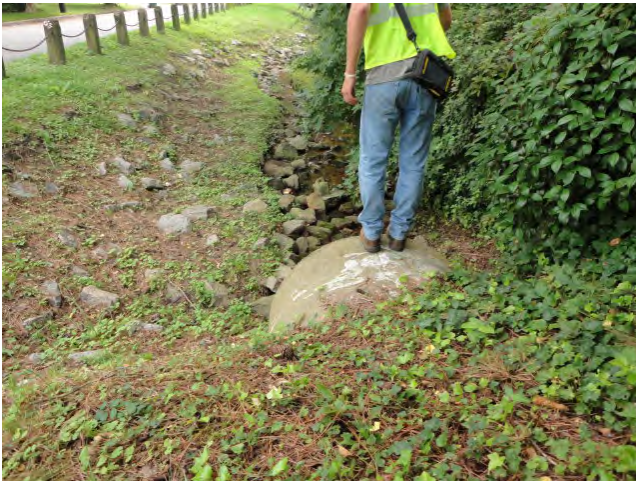
Structure Number **J0689**

Pipe Condition G (**P**oor , **F**air , **G**ood , **A**waiting Install , **R**emoved from Service)

Ditch Condition	Bottom Width, ft	Top Width, ft	Depth, ft	Side Slopes (ft/ft)
G	5	19	4	1.75

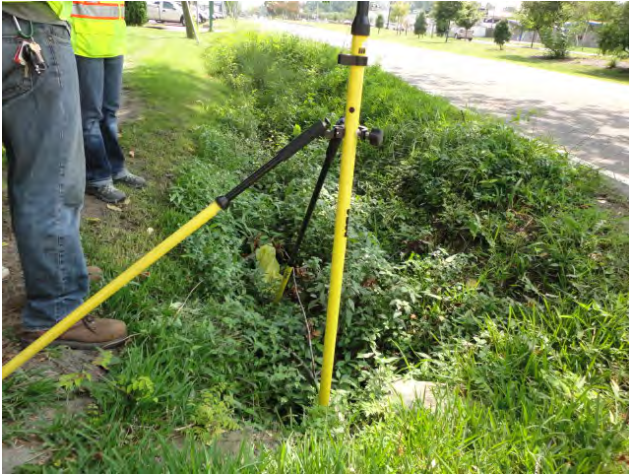
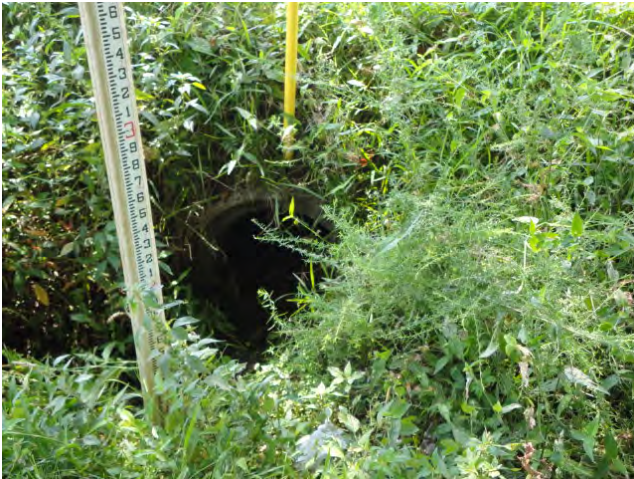
Structure Number **J071065**

Pipe Condition G (**P**oor , **F**air , **G**ood , **A**waiting Install , **R**emoved from Service)

Ditch Condition	Bottom Width, ft	Top Width, ft	Depth, ft	Side Slopes (ft/ft)
G	3.5	5	2.3	0.3

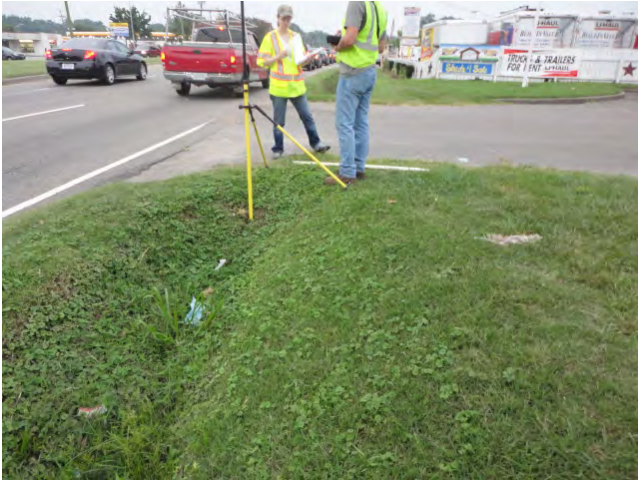
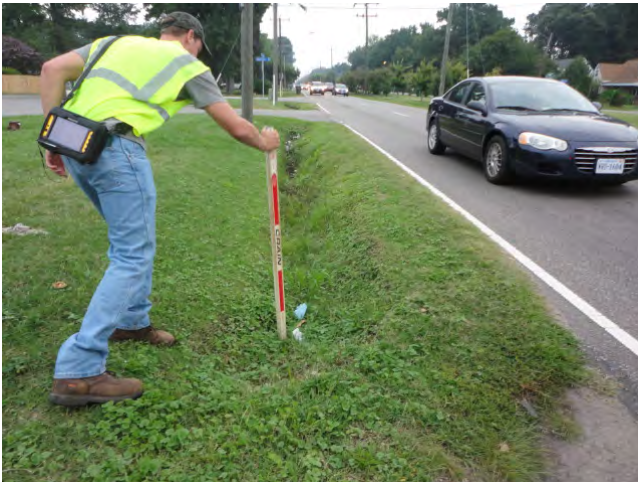
Structure Number **J071094**

Pipe Condition P (**P**oor , **F**air , **G**ood , **A**waiting Install , **R**emoved from Service)

Ditch Condition	Bottom Width, ft	Top Width, ft	Depth, ft	Side Slopes (ft/ft)
G	1.5	4.5	2.3	0.65

Notes: could not really locate pipe to check condition or type

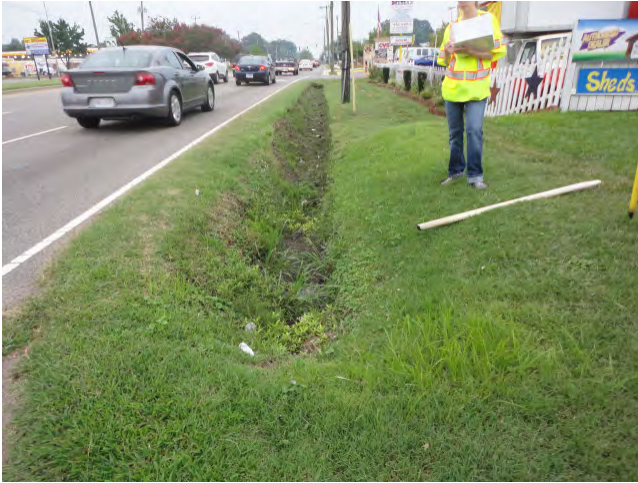
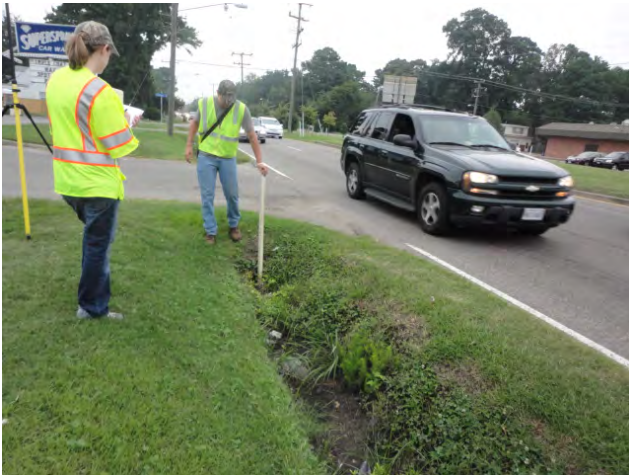
Structure Number **J071095**

Pipe Condition P (**P**oor , **F**air , **G**ood , **A**waiting Install , **R**emoved from Service)

Ditch Condition	Bottom Width, ft	Top Width, ft	Depth, ft	Side Slopes (ft/ft)
G	2	4.4	2	0.60

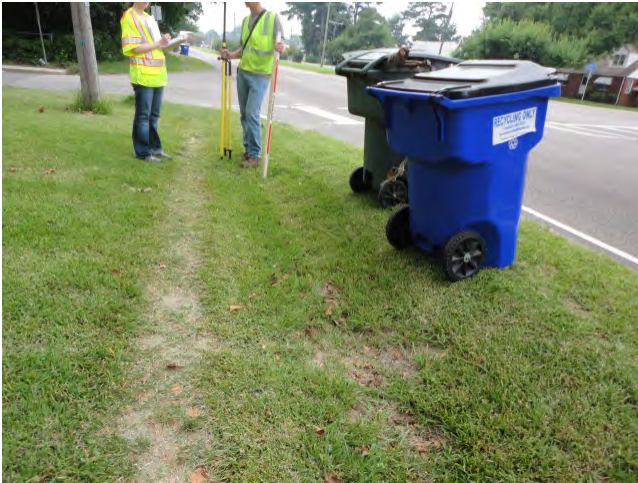
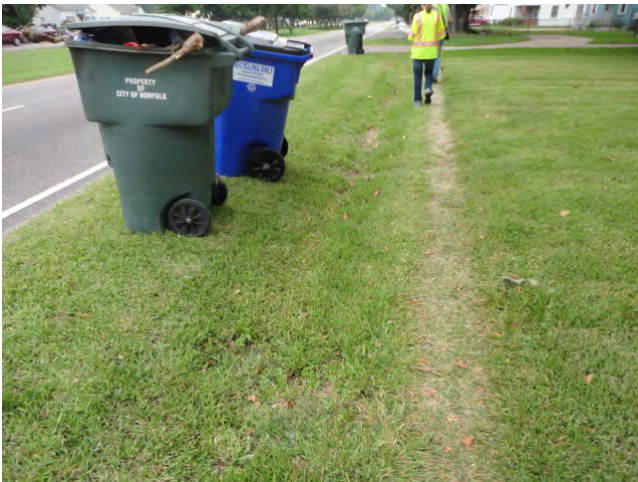
Structure Number **J073321**

Pipe Condition NA (Poor , Fair , Good , Awaiting Install , Removed from Service)

Ditch Condition	Bottom Width, ft	Top Width, ft	Depth, ft	Side Slopes (ft/ft)
F	0.75	2	0.6	1.04

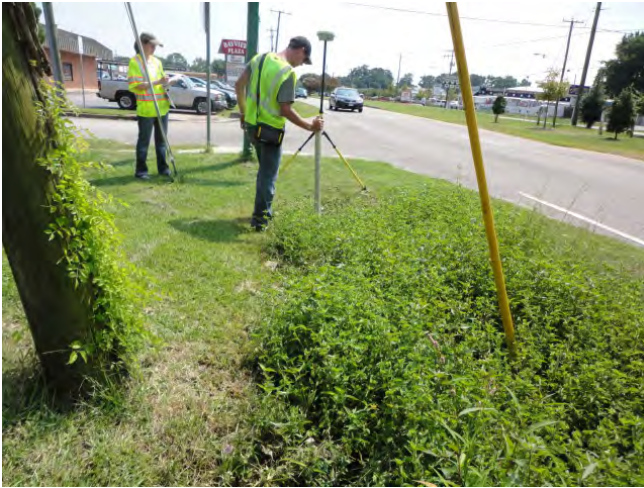
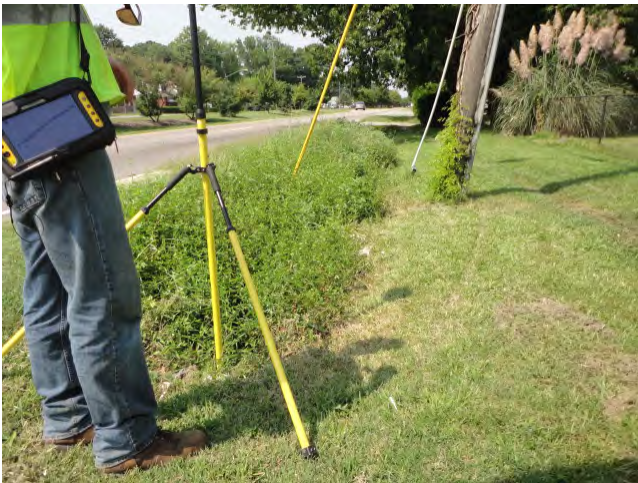
Structure Number **J07409**

Pipe Condition E (**P**oor , **F**air , **G**ood , **A**waiting Install , **R**emoved from Service)

Ditch Condition	Bottom Width, ft	Top Width, ft	Depth, ft	Side Slopes (ft/ft)
G	1	3.5	1.8	0.7

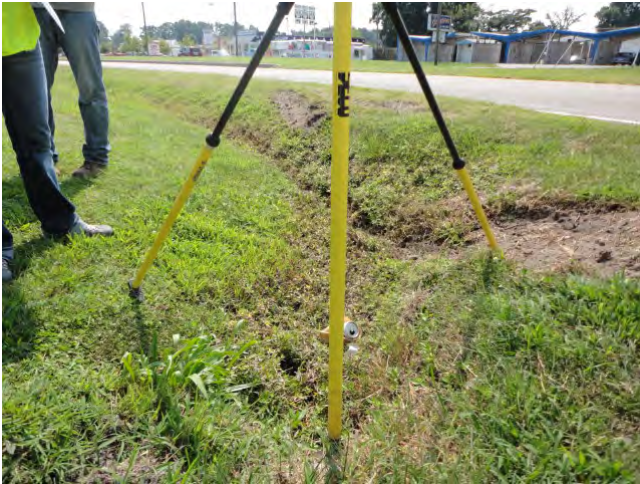
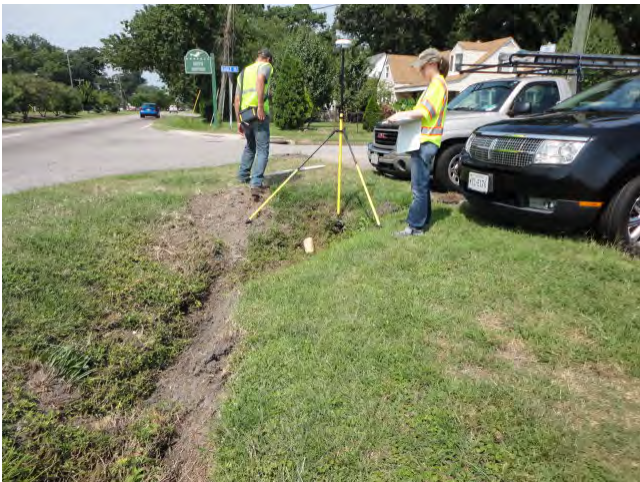
Structure Number **J07412**

Pipe Condition G (**P**oor , **F**air , **G**ood , **A**waiting Install , **R**emoved from Service)

Ditch Condition	Bottom Width, ft	Top Width, ft	Depth, ft	Side Slopes (ft/ft)
G	2	4	1.8	0.55

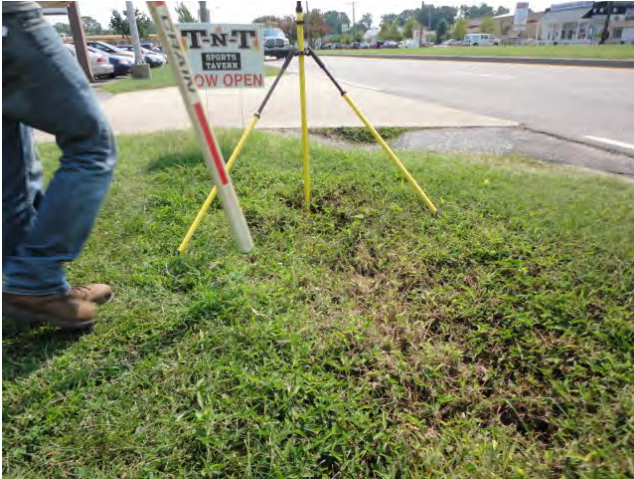
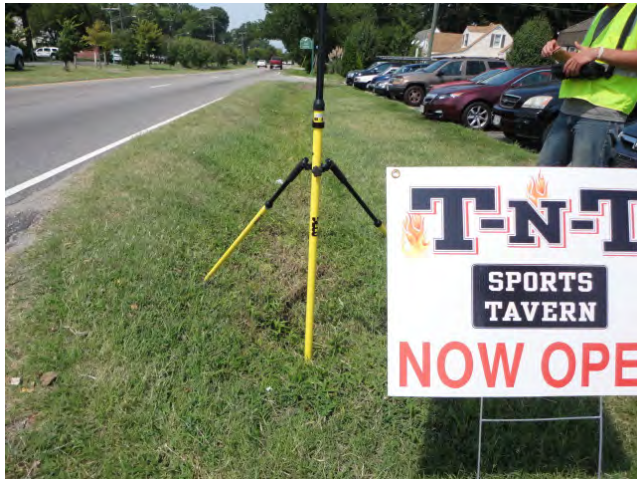
Structure Number **J07416**

Notes: pipe squashed and blocked by vegetation; top of bank of ditch is parking lot

Pipe Condition P (**P**oor , **F**air , **G**ood , **A**waiting Install , **R**emoved from Service)

Ditch Condition	Bottom Width, ft	Top Width, ft	Depth, ft	Side Slopes (ft/ft)
G	1.10	4	1.5	0.96

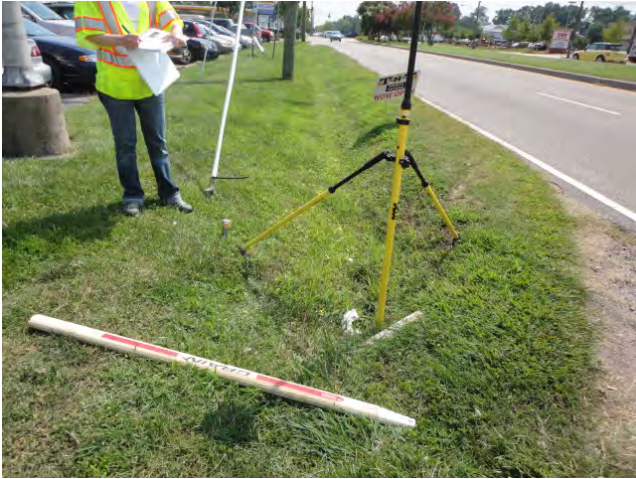
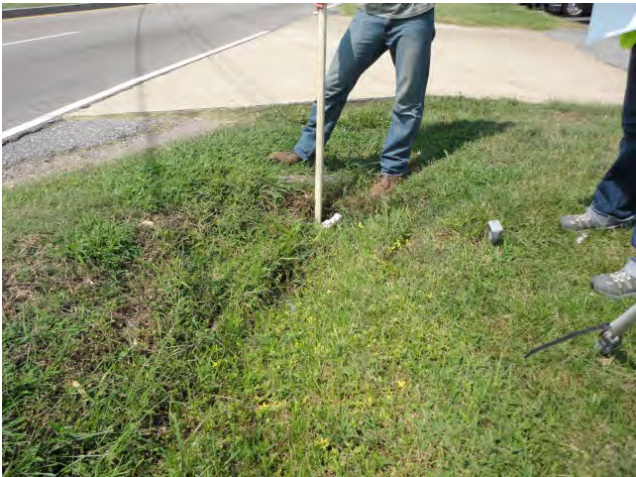
Structure Number **J07417**

Pipe Condition P (**P**oor , **F**air , **G**ood , **A**waiting Install , **R**emoved from Service)

Ditch Condition	Bottom Width, ft	Top Width, ft	Depth, ft	Side Slopes (ft/ft)
G	1.5	4	2	0.625

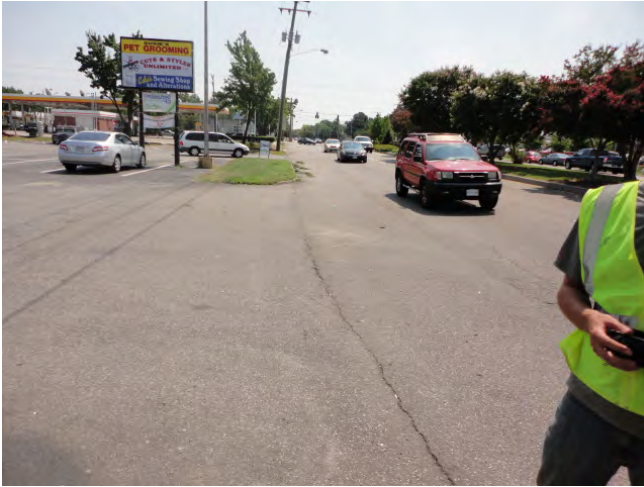
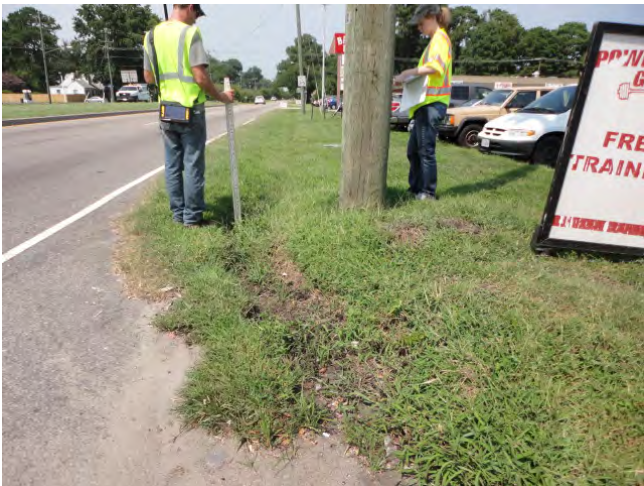
Structure Number **J07419**

Pipe Condition NA (Poor , Fair , Good , Awaiting Install , Removed from Service)

Ditch Condition	Bottom Width, ft	Top Width, ft	Depth, ft	Side Slopes (ft/ft)
G	0.5	3	1.5	0.83
